Asbestos Management Survey

Brimpton Village Hall Crookham Common Road Brimpton, Reading RG7 4ST

Surveyed On: 30 Aug 2024

Job Id: 2979

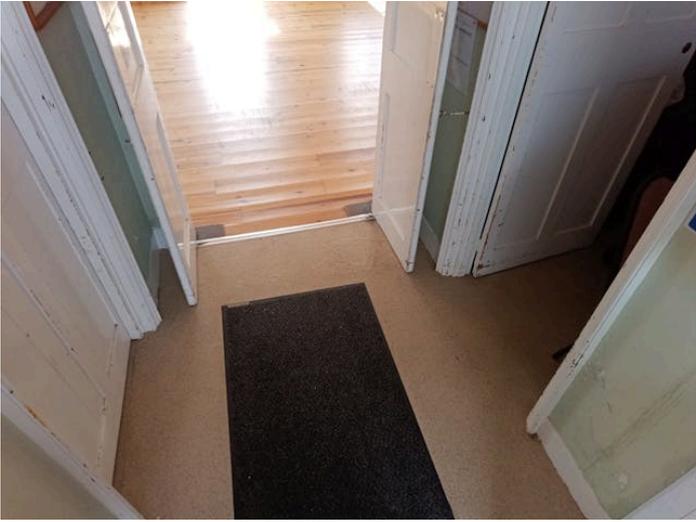
Building	Main Building	Level	0
Location	001 - Hallway	Item

Location Notes	Vinyl flooring to concrete floor, plastered brick walls, plasterboard ceiling

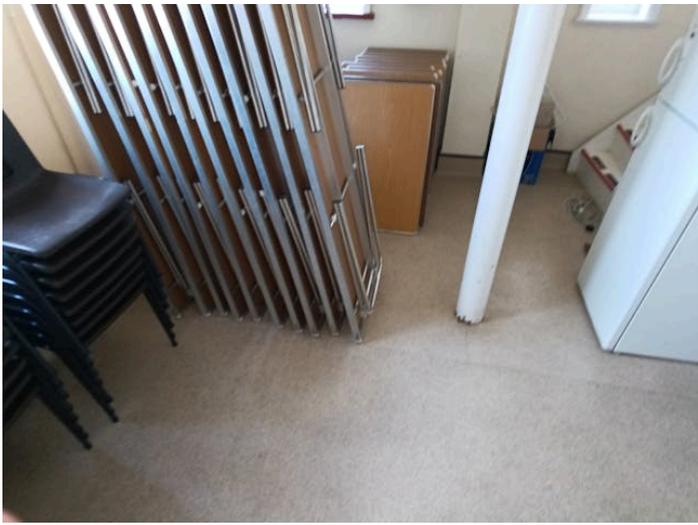
Building	Main Building	Level	0
Location	002 - Store Room	Item

Location Notes	Vinyl flooring to concrete floor, plastered brick walls, plasterboard ceiling

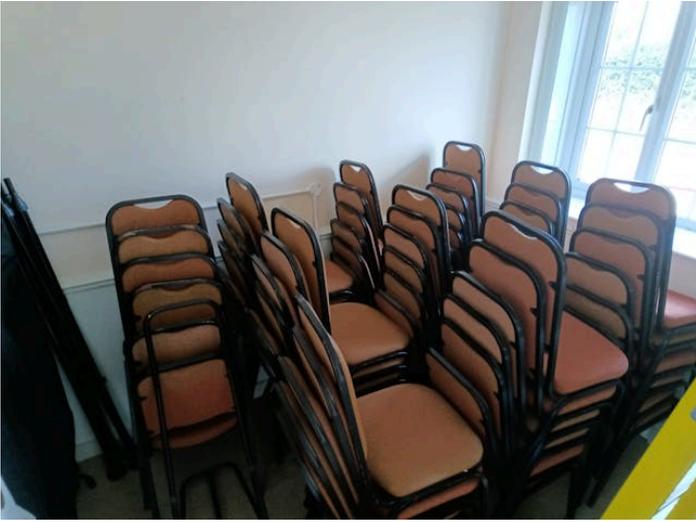
Building	Main Building	Level	0
Location	003 - Store Room	Item

Location Notes	Vinyl flooring to concrete floor, plastered brick walls, plasterboard ceiling

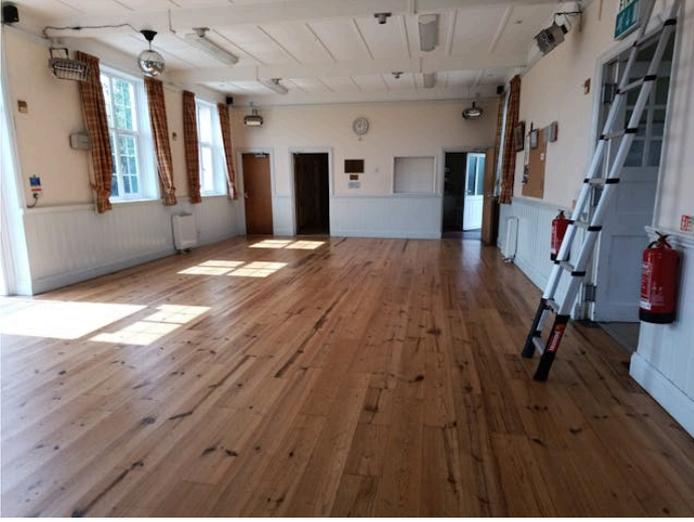
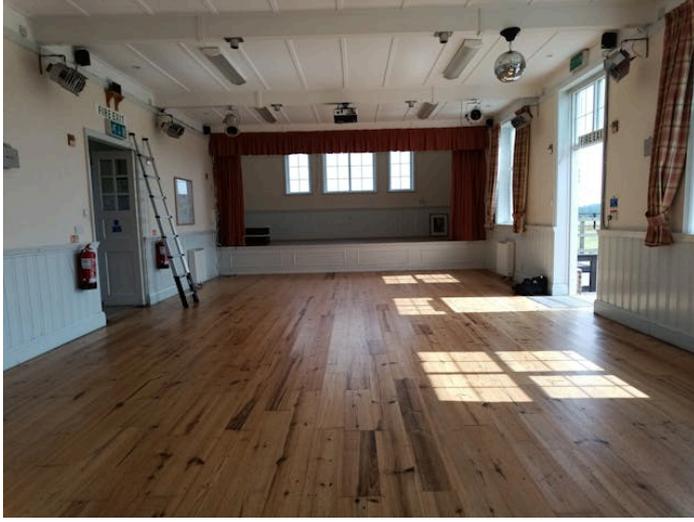
Building	Main Building	Level	0
Location	004 - Hall	Item

Location Notes	Timber floor, plastered brick walls with timber panelling, timber ceiling

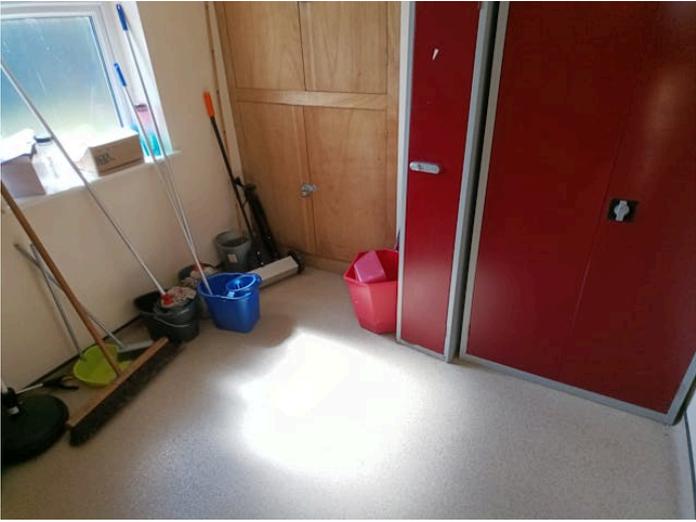
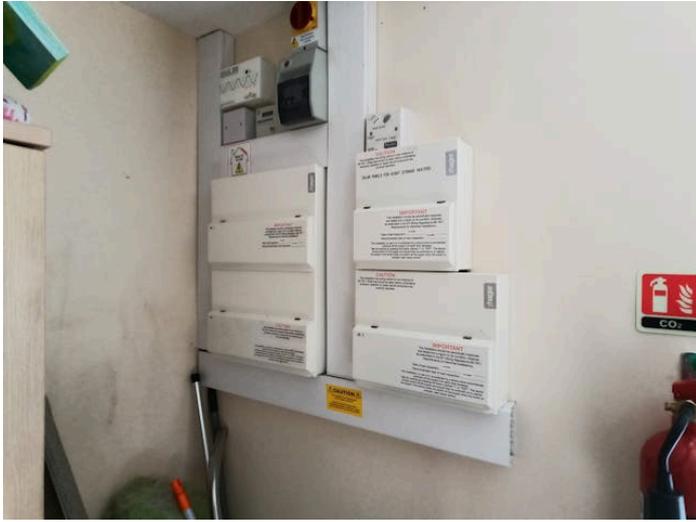
Building	Main Building	Level	0
Location	005 - Store Room	Item

Location Notes	Vinyl flooring to concrete floor, plastered brick walls, wall mounted electrics, plasterboard ceiling

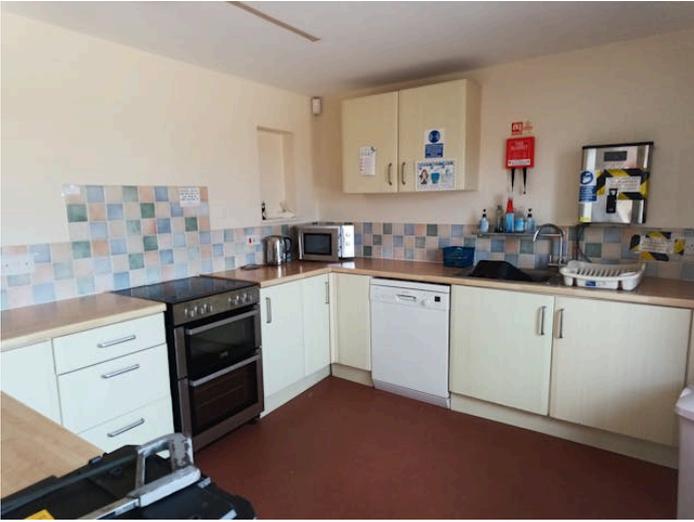
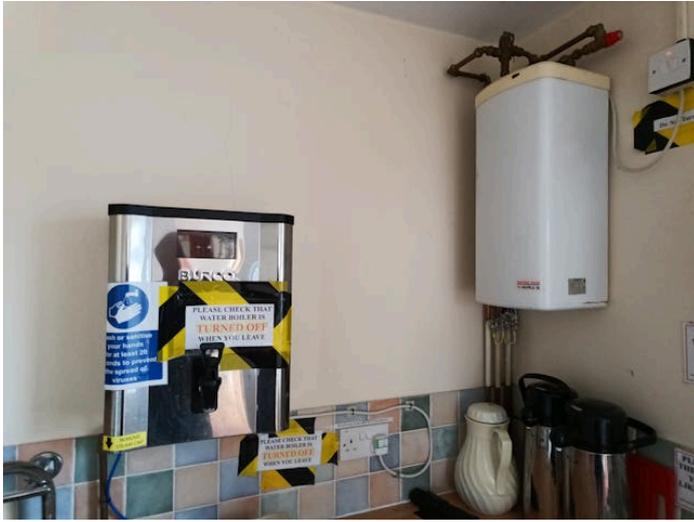
Building	Main Building	Level	0
Location	006 - Kitchen	Item

Location Notes	Vinyl flooring to concrete floor, plastered brick walls, wall mounted water heater, plasterboard ceiling

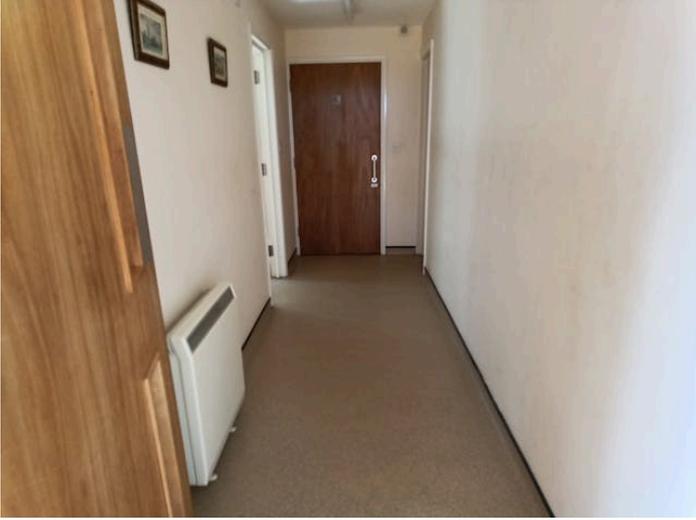
Building	Main Building	Level	0
Location	007 - Lobby	Item

Location Notes	Altro flooring to concrete floor, plastered brick walls, plasterboard ceiling

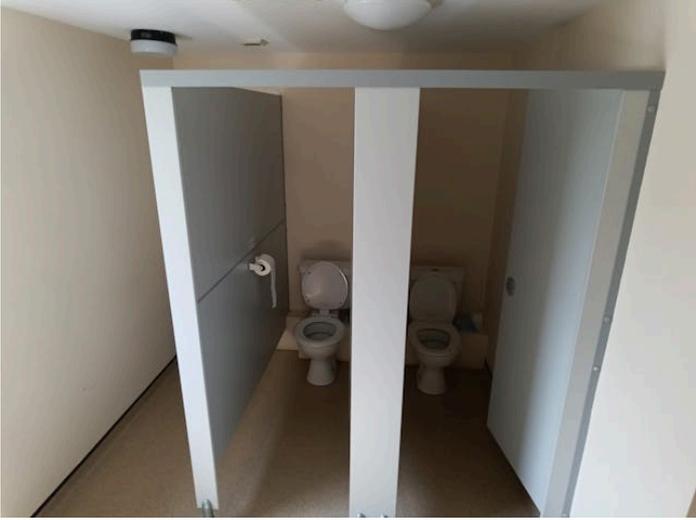
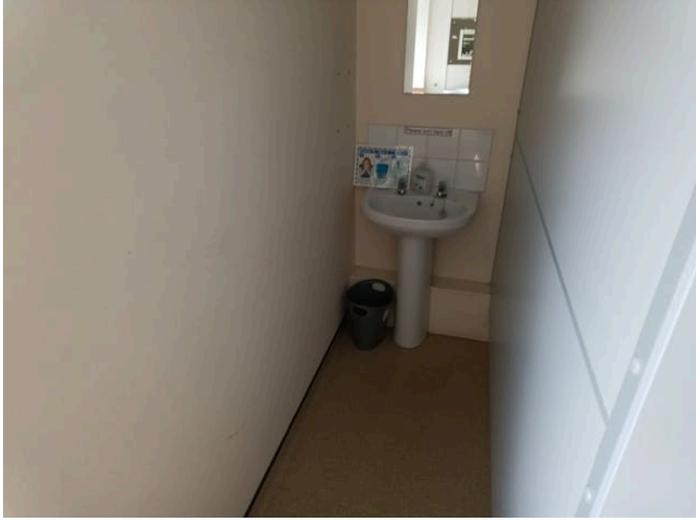
Building	Main Building	Level	0
Location	008 - Toilet	Item

Location Notes	Altro flooring to concrete floor, plastered brick walls, ceramic amenities, plasterboard ceiling

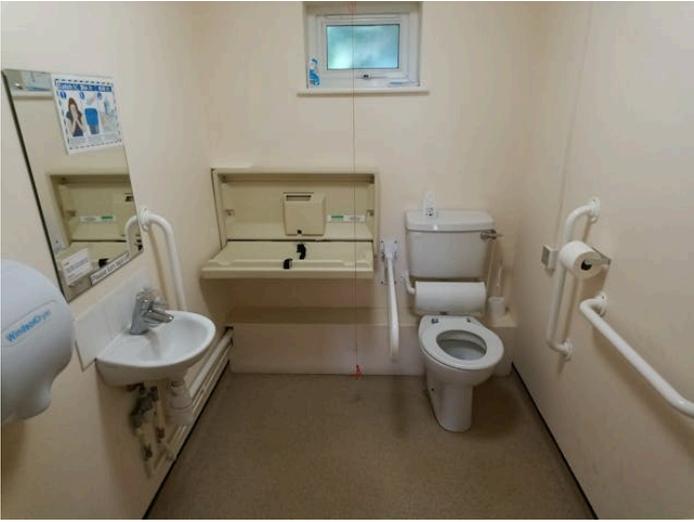
Building	Main Building	Level	0
Location	009 - Toilet	Item

Location Notes	Altro flooring to concrete floor, plastered brick walls, ceramic amenities, plasterboard ceiling

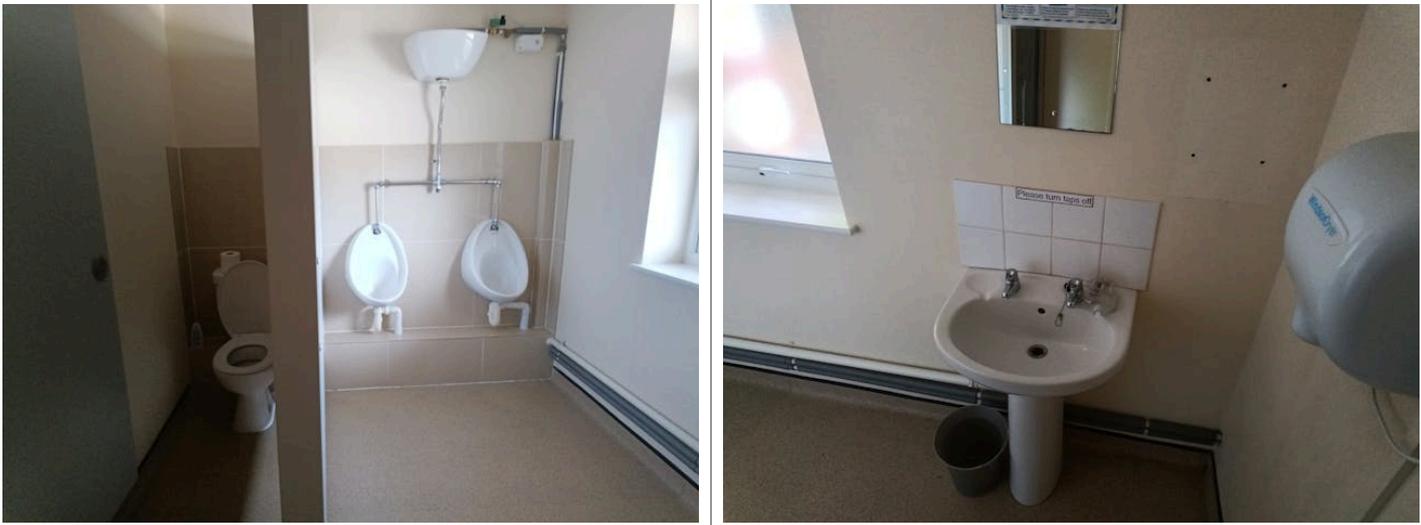
Building	Main Building	Level	0
Location	010 - Toilet	Item

Location Notes	Altro flooring to concrete floor, plastered brick walls, ceramic amenities, plasterboard ceiling

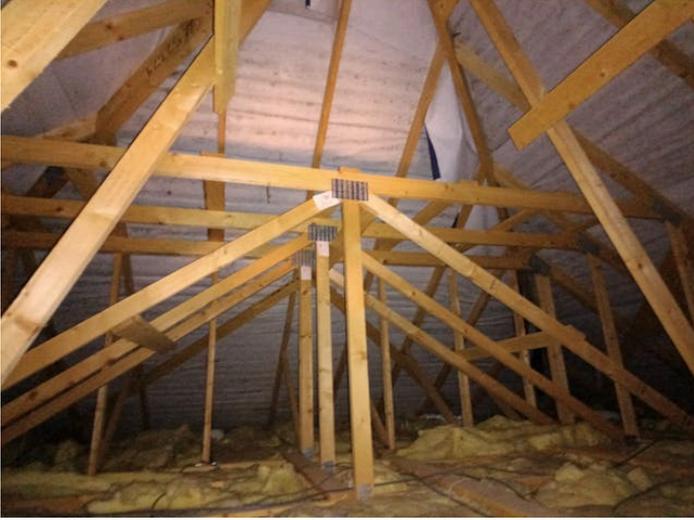
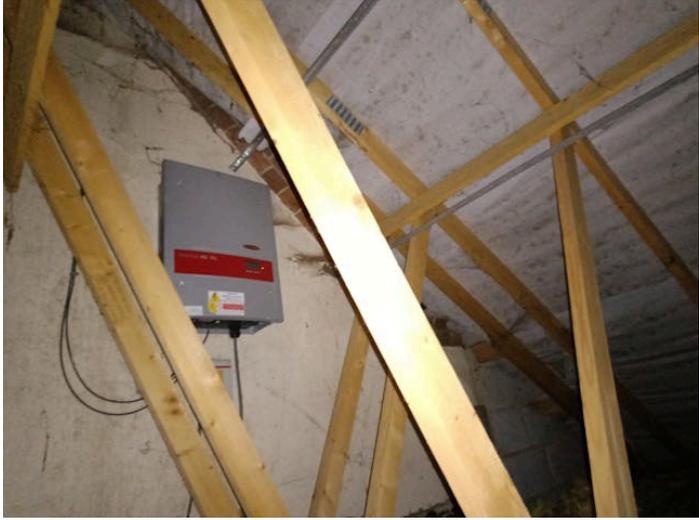
Building	Main Building	Level	1
Location	011 - Loft	Item

Location Notes	MMMF insulation to plasterboard ceiling, brick gable ends, timber battened roof

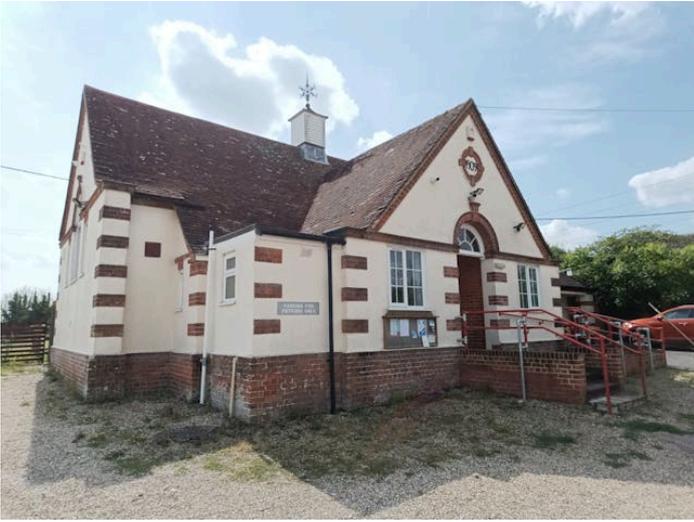
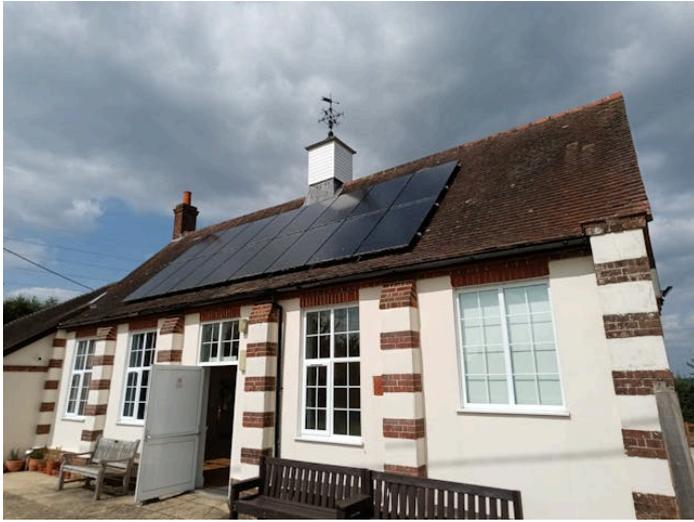
Building	Main Building	Level	External
Location	012 - External	Item

Location Notes	Masonry brick built, Upvc windows and doors, plastic rainwater goods, timber soffit boards and a clay tiled pitched roof
